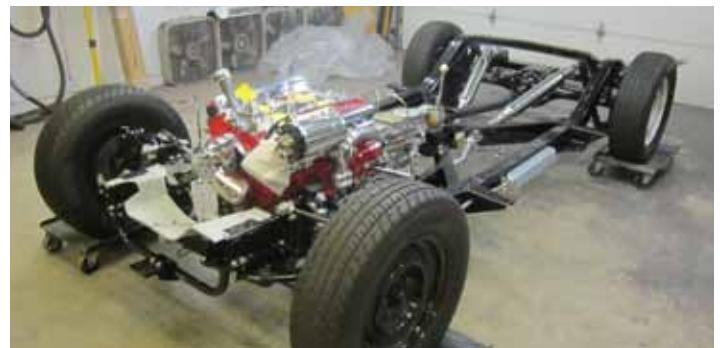
Back from being powder coated, the frame and suspension parts were assembled. The 283 ci small block engine had been bored 0.40 over in 1975. Now it was refreshed, balanced and blue printed and painted red. Brake lines are added to the frame and Tremec 5-speed (600 series) transmission and engine installed. Lower fan shroud, fan, generator, oil cooler, exhaust, intake manifold and much more are installed. The finished chassis is wrapped in plastic to keep it clean while finishing the body work and painting the body. Here come the guys again to put the body back on the chassis!!! More beans!

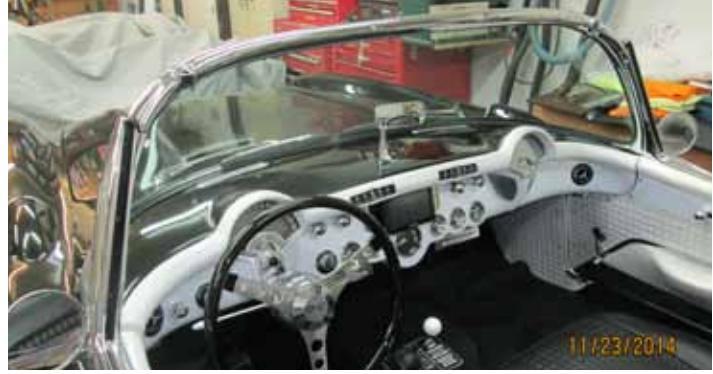
The dash has original-type gauges, which were rebuilt by Clocks by Roger. The tachometer was changed to electrical and the ammeter was changed to a volt meter. The air conditioner vents are in the center of the dash pad and on each side. The A/C takes up all the space of the old radio. The back up camera replaces the radio face and retractable cup holders are below the dash.

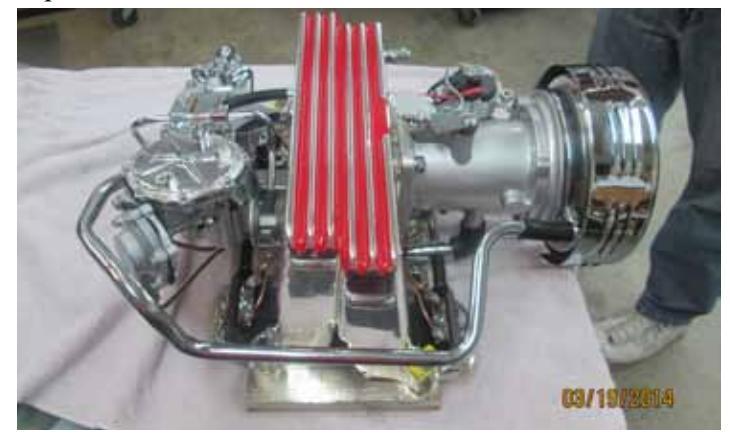
Bill had cleaned, chromed, painted and or replaced every part of the 4900 series fuel injection unit for 1957-58 before installing it.

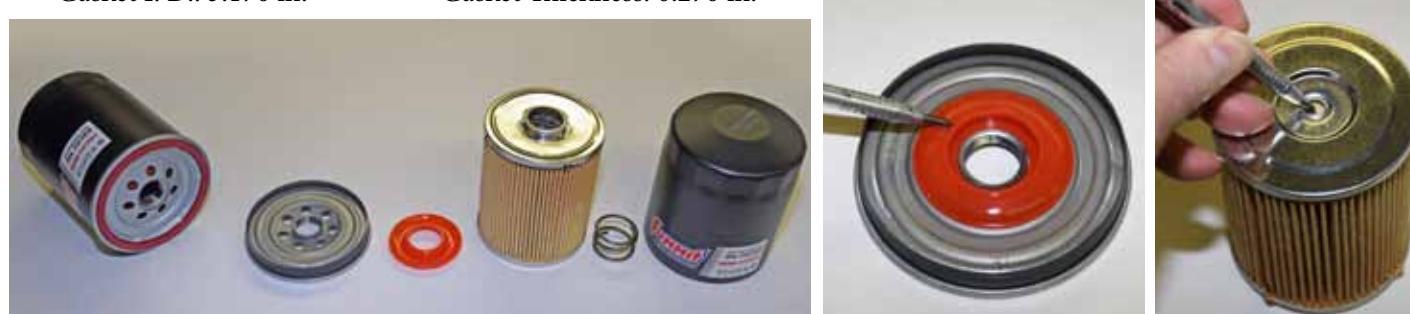
Here's the Summit Racing filter both complete and stripped down to the bare elements. The Summit Racing filter makes use of a center post with drilled holes. Check out the next photo to see what we mean.

Here's the anti-drainback valve incorporated in the Summit Racing oil filter located beneath the baseplate or "Tapping Plate." This ensures oil remains in the filter following engine shutdown. post and get back into the engine.

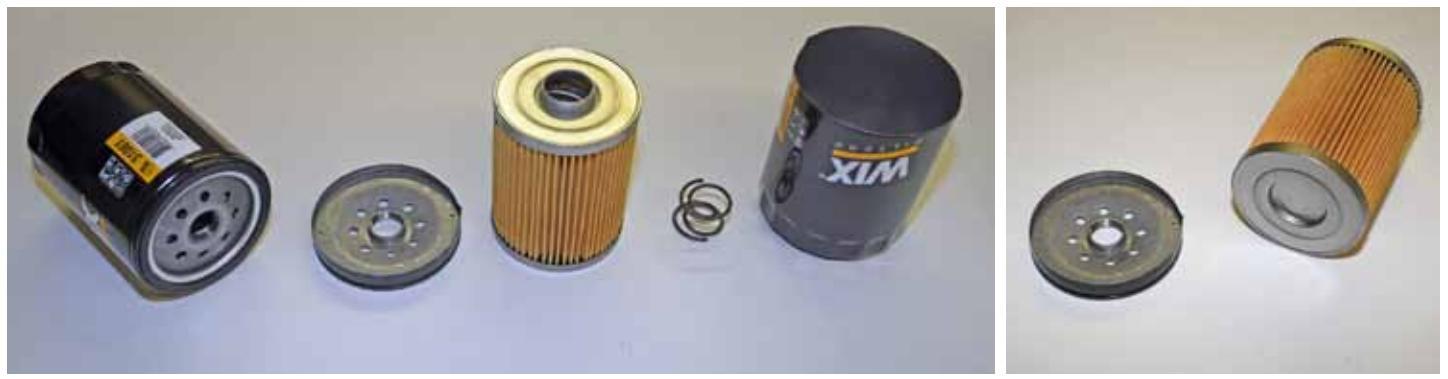
Here's the Wix replacement (conventional Chevy) filter stripped down. The center post incorporates drilled holes.

The Wix replacement filter doesn't have a bypass valve or an anti-drainback device.

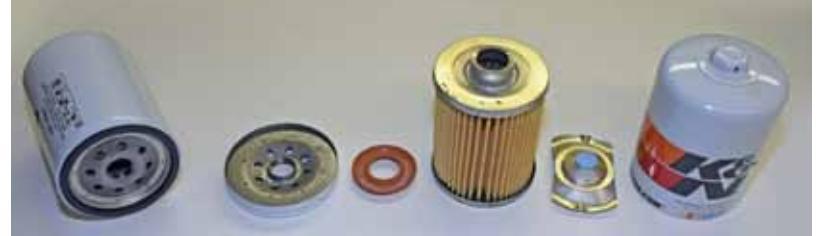
This is the K&N filter stripped down to the basics, where you can see the filter's louvered center post.

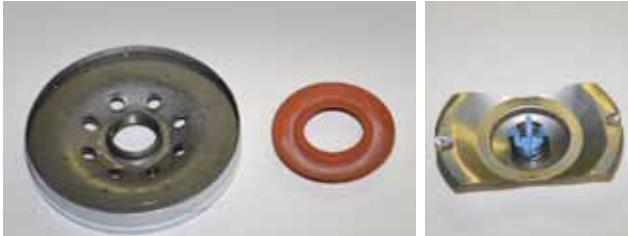
K&N makes use of a drainback valve made from a silicone material. Get another look in the next photo.

The K&N filter uses this bypass relief valve situated within the end cap of the element. It's equipped with an internal relief spring.

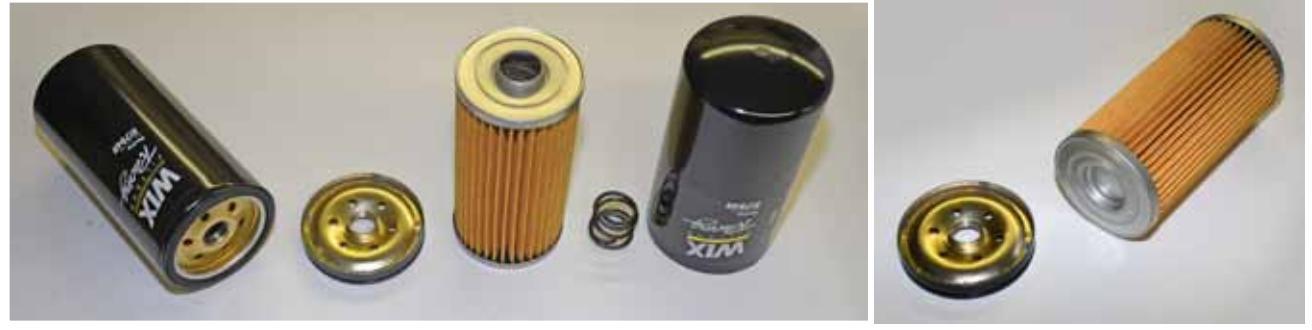
Here's the long Wix race filter broken down into separate pieces. It incorporates a drilled center post. The Wix race filter does not include an anti-drainback valve

in the assembly, nor does it make use of a bypass valve.

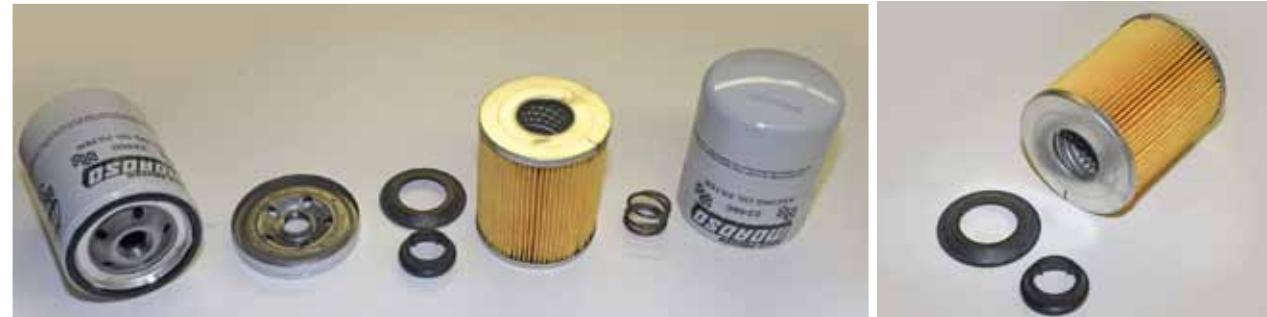
This is the Moroso race filter broken down. It incorporates a louvered center post assembly.

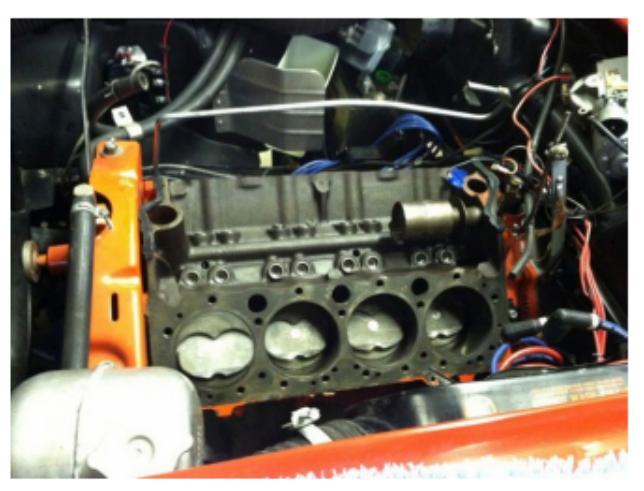
When I took the heads off the top of the pistons had an oily gum on them. I was certainty sucking in oil from somewhere. When I took out the spark plugs the spark gap was almost closed due to the accumulation of burnt oil. Did I have a broken piston ring or was the wear between the valve and valve guide really bad for some reason. Whose fault was it, certainty not mine. The above picture was taken after I cleaned the pistons of all that oily residue.

The heads looked fine to me as did the piston rings. I took the heads to a local shop in Richmond VA to have new valve guides installed even though they felt fine to me. I dropped off the heads and was talking to the mechanic about my problem. He was describing their process for grinding valve seats and he decided to take a valve out of the head to demonstrate their technique to me. As he took out the first valve he said under his breath "wow, that's odd". I immediately asked him to explain what was odd. He said that these heads didn't have any oil seals installed. In an instant I remembered a conversation I had over the phone with the guy's in California. They had heated up the head in an oven and then repair the crack by welding. They installed new valve guides and re-ground the seats. They did not have any oil seals on hand and told me over the phone that they would ship the heads back to me assembled and all I had to do was install new oil seals. Of course, I said I would, but this conversation would lay dormant in my mind until this instant. For all this time I was running without any oil seals. The oil in the valve train area of the head was running down the valve shaft and being sucked into the combustion chamber, and of course when I rebuilt the engine, I installed a high volume oil pump so the engine would get plenty of oil

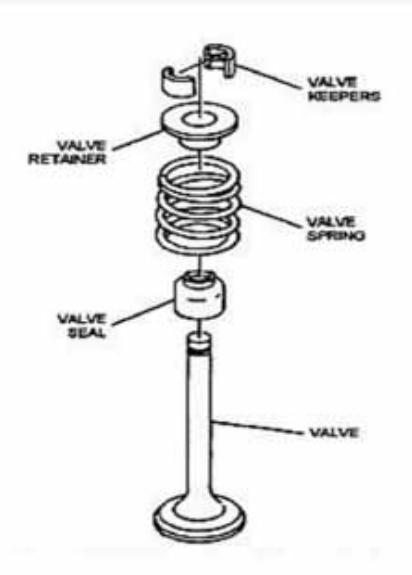
In my defense you cannot really see the oil seals inside the valve springs unless you really look hard.

After installing new oil seals I do not have any smoking issues so if you were following me at the MASACC trip to Assateague Island you no longer needed your smoke/gas mask. It is also easier to adjust the fuel/air ratio as I do not have to account for oil burning in the combustion chamber as well as the fuel. Since most of us do not drive our corvettes all that much I wonder how long the oil seals last before degradation due to age and require replacement to prevent increased oil leakage?
